300 South Bedford Street
Madison, Wisconsin 53703
608.257.5321

1600 North 6th Street
Milwaukee, Wisconsin 53212
414.272.8788

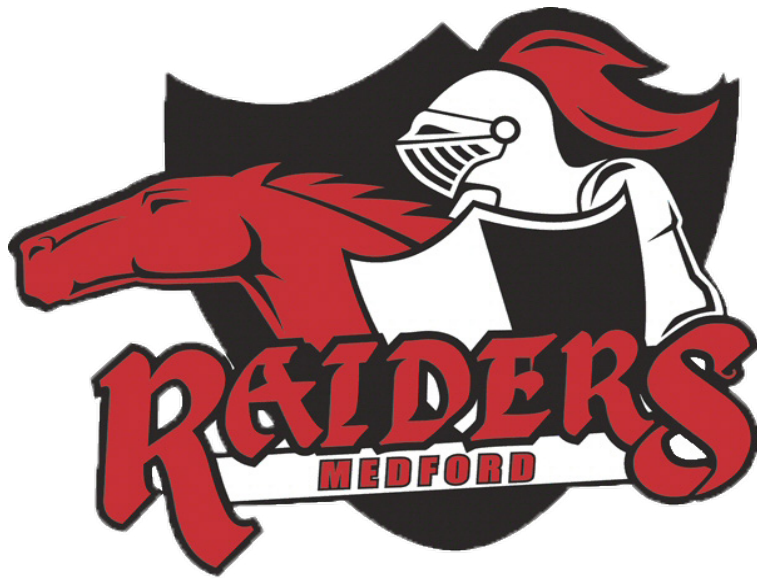
- Asphalt replacement is needed around the MASH site.
- Drainage and facility upgrades at softball and baseball fields.
- Tennis court repairs are needed
- Roofing replacements needed for sections at the end of useful life (20 years)
- Caulking and tuckpoint of exterior walls are needed.
- Replace Remaining 9x9 Floor Tile as it's indicative of asbestos containing materials
- Replace miscellaneous finishes that are failing throughout the building
- Replace the domestic water distribution lines
- Replace sections of hot water pipe and insulation
- Add air conditioning to the main core spaces
- Boiler Replacement needed within 10-year maintenance period
- Replace main panels and switchgear as it is past its useful life
- Energy efficiency LED lighting upgrades are recommended

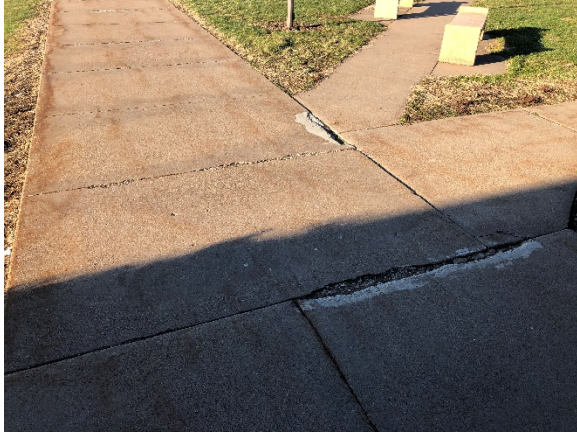
Front entrance sidewalk is damaged and uneven in a few spots.

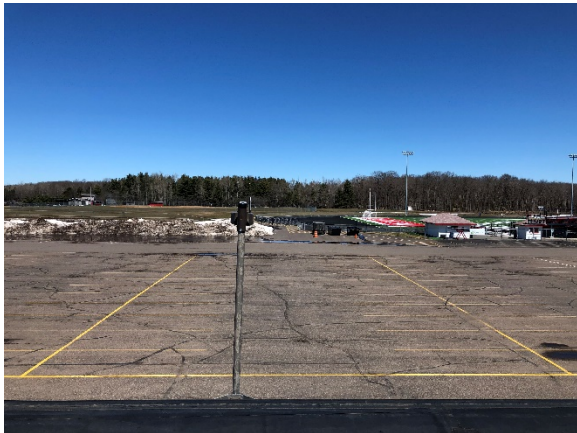
North parking lot. Several areas have been patched in the past. Asphalt is in poor condition.

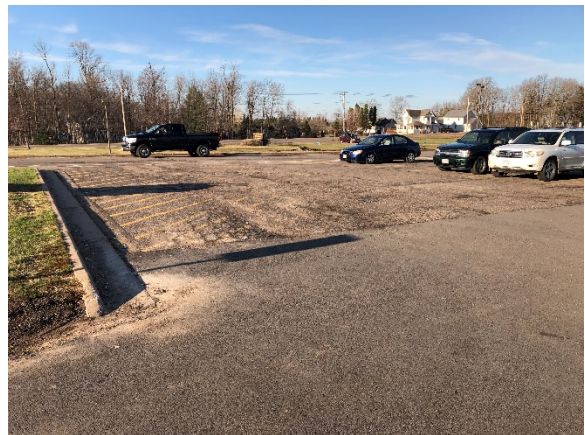
West parking lot asphalt is in poor condition and crumbling.

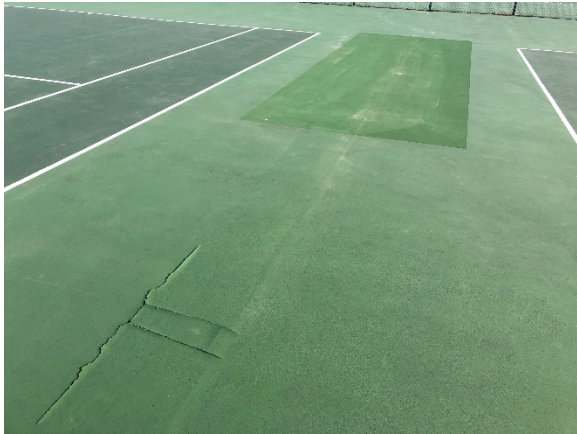
Tennis courts have been repaired in the past from the surface delaminating from the base. It continues to be an issue every year.

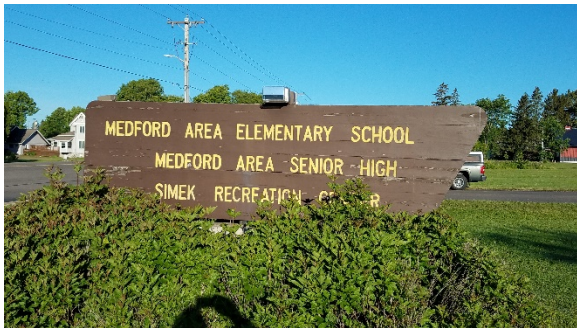
The existing monument sign is showing signs of age. It either needs to be repaired or replaced.

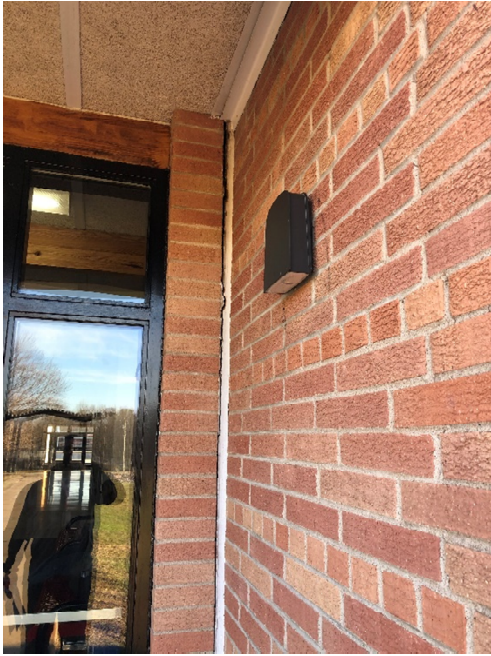
Exterior caulk joint is tearing away from exterior brick and needs to be replaced.

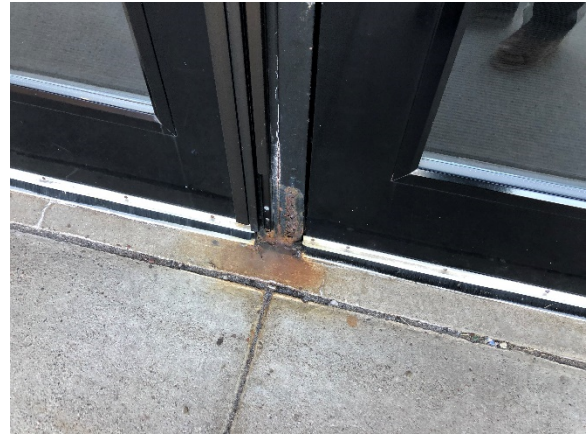
Exterior hollow metal door frame rusting at the bottom.

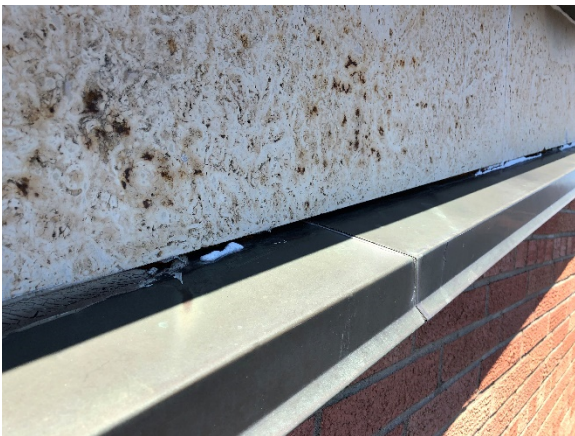
Exterior caulking is missing at the stone band around the gym exterior wall.

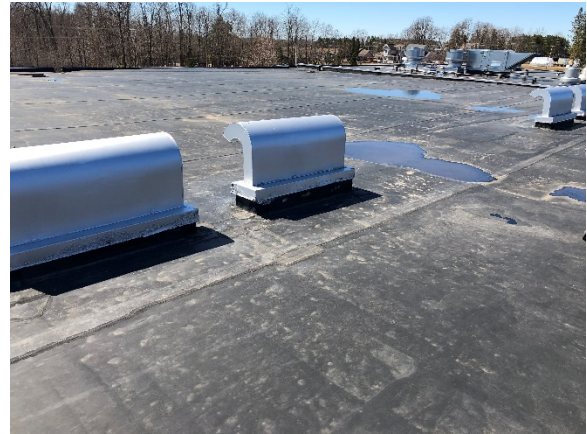
The roofs are in good shape; however, some roofs are nearing their life span (20 years).

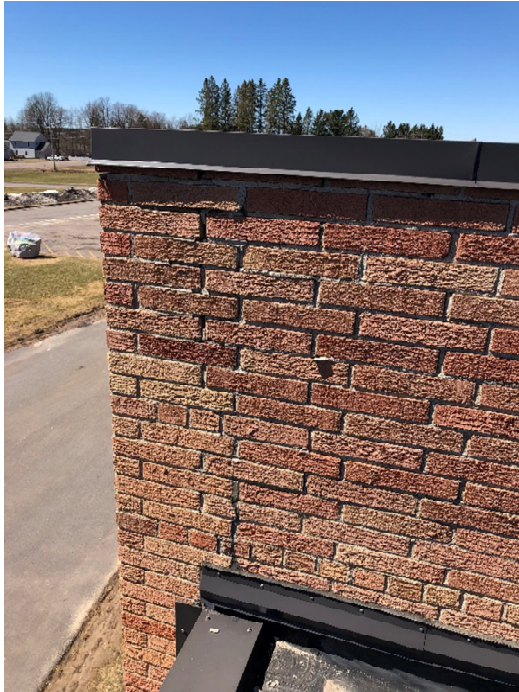
Corner of pool building is cracking and the inside shows signs of water intrusion.

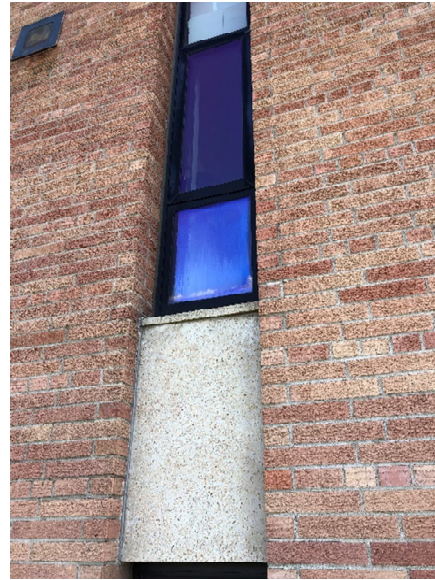
Exterior glazing panel is foggy and should be replaced. A few other window gaskets have come loose and need to be addressed.

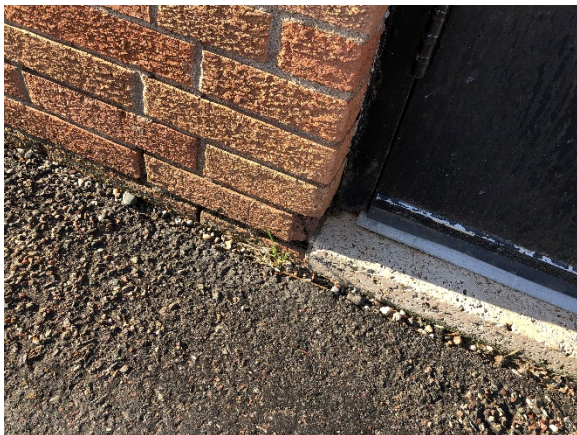
Exterior brick's mortar joint is wearing away. Tuckpointing is required.

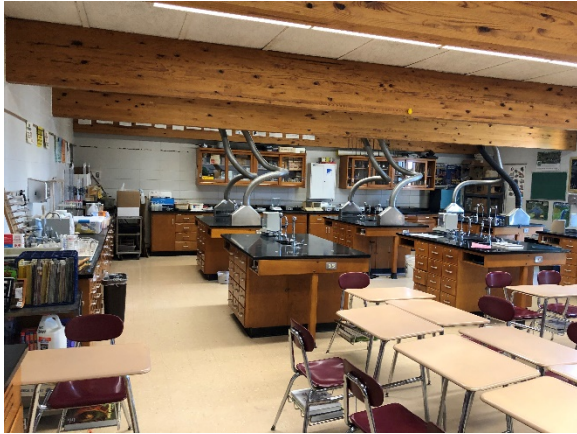
The original wood casework is in good condition and should be maintained.

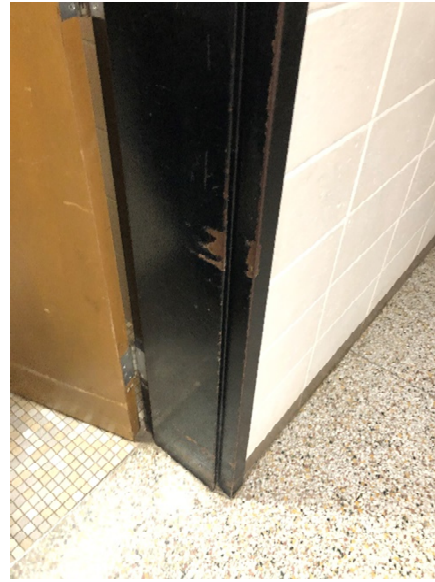
The interior door frames throughout the building are hollow metal frames and are in fair to good condition.

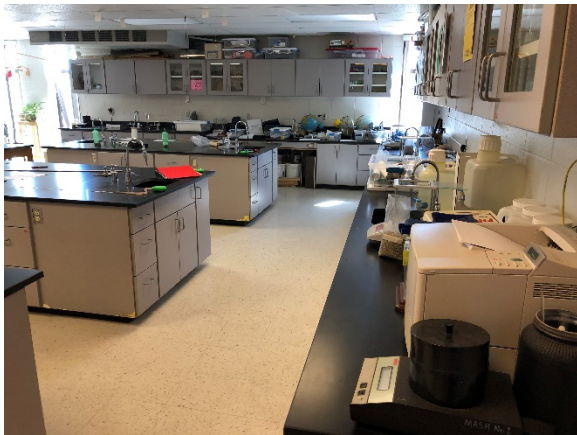
The casework installed in the 1996 addition and art classrooms are chipped and damaged in areas.

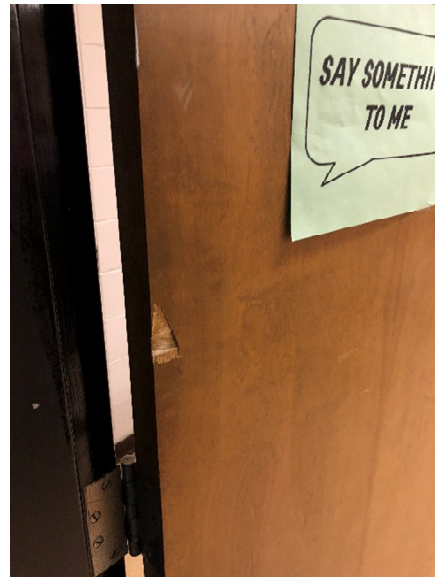
The interior wood doors are showing signs of their age and use. This door like many others have chips and scratches in them.

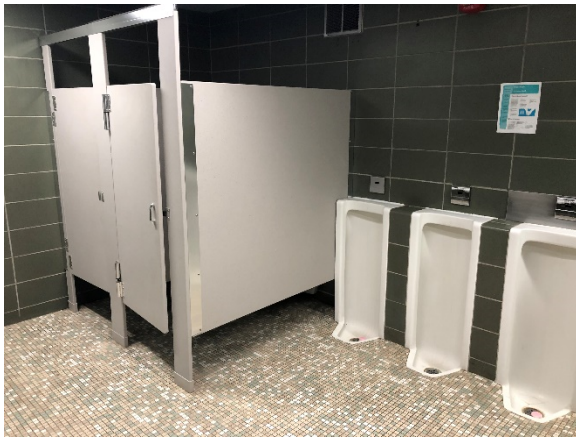
Bathrooms in the school are in good condition with glazed block walls and ceramic tile floors. Nearly all toilet partitions have been updated over the years.

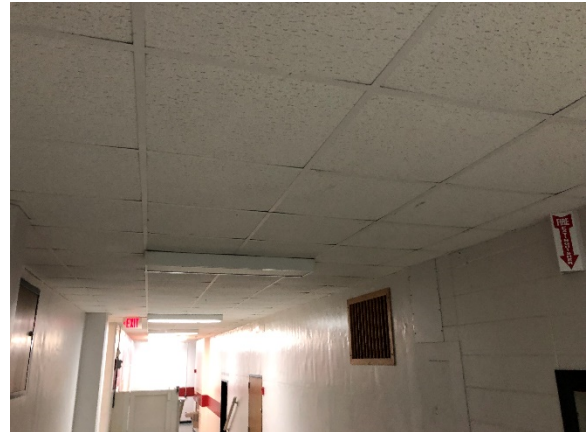
Ceilings on the lower level are mainly 2x2 acoustical ceiling tile and grid. The tiles are sagging from humidity and are chipped and worn.

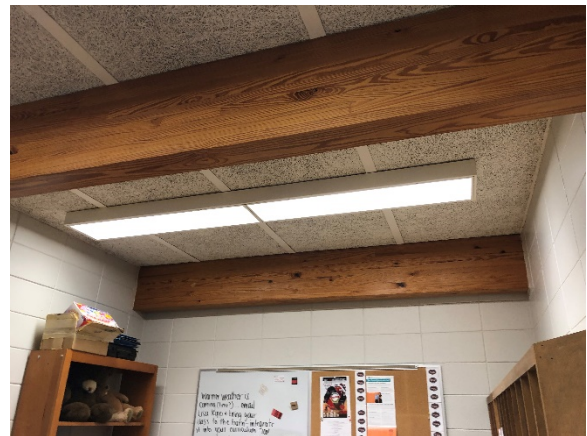
Ceilings on the main level with exposed wood beams.

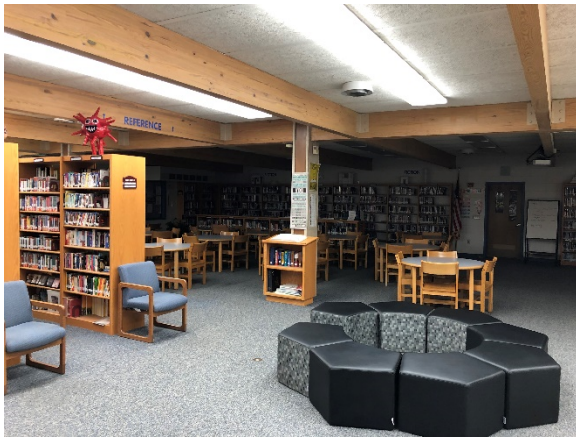
Carpet in the LMC and support spaces are showing signs of wear.

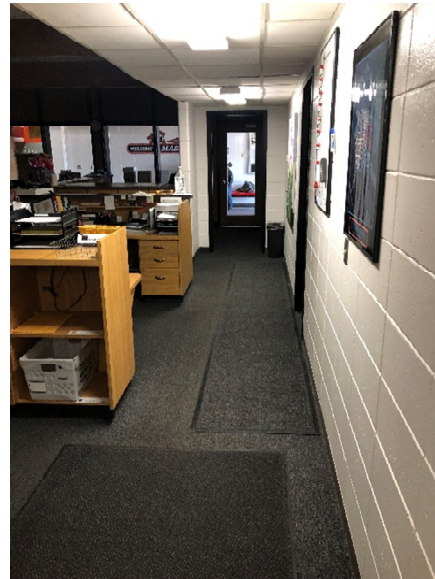
Carpet in the office/admin area are showing signs of wear.

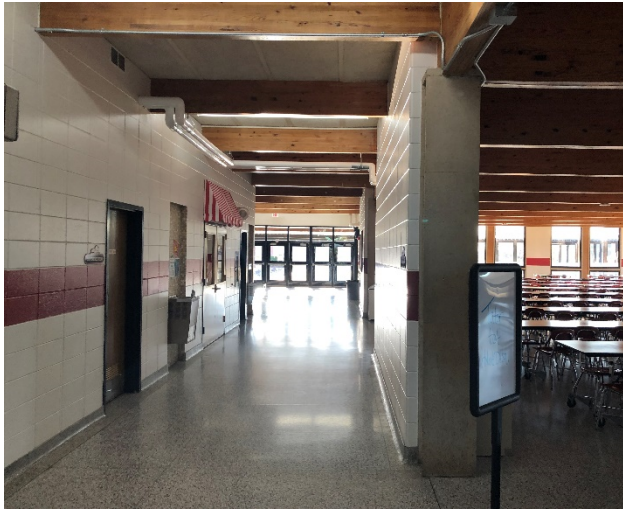
Terrazzo flooring throughout the corridors and cafeteria are in good condition.

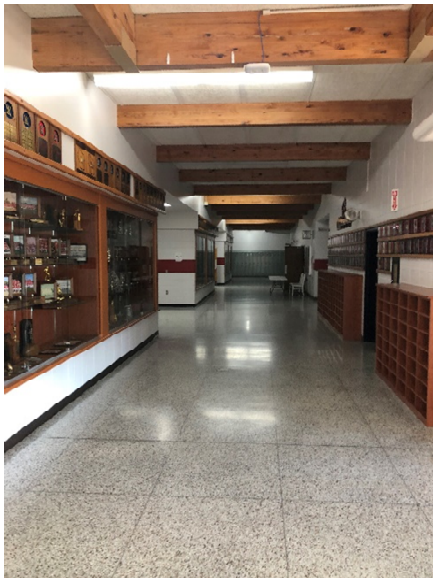
Another photo of the terrazzo flooring and exposed wood beam ceilings.

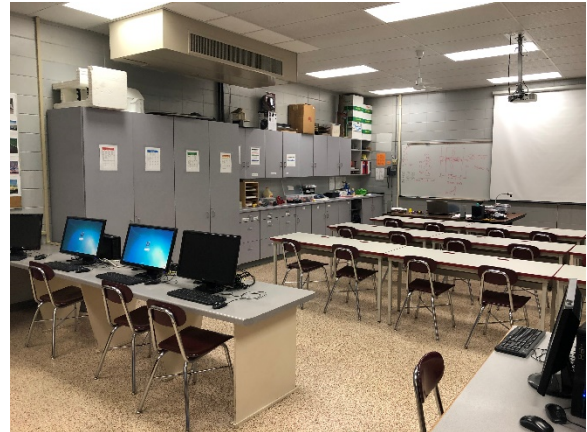
The epoxy flooring in the STEM area is in good condition.

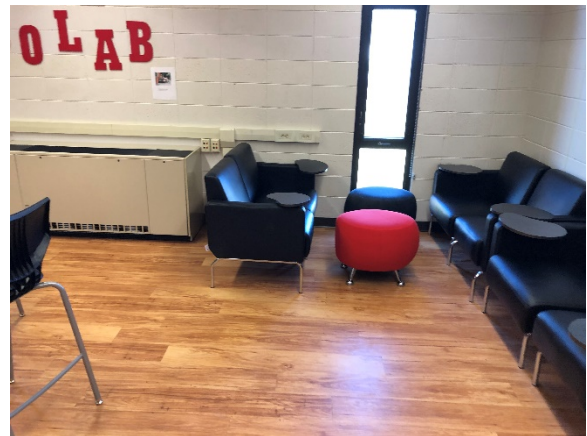
A few classrooms on the main level have received new flooring throughout the years.

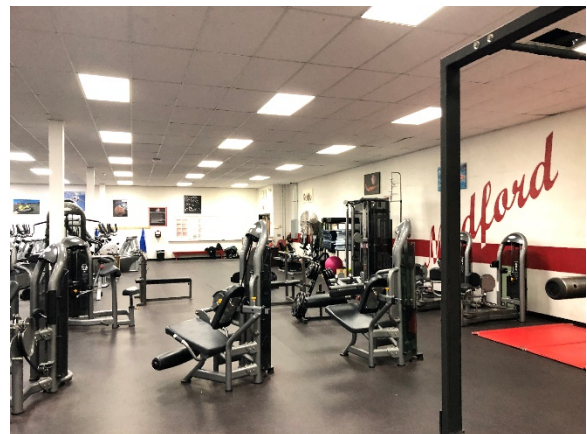
The rubber flooring in the weight room area is in good condition.

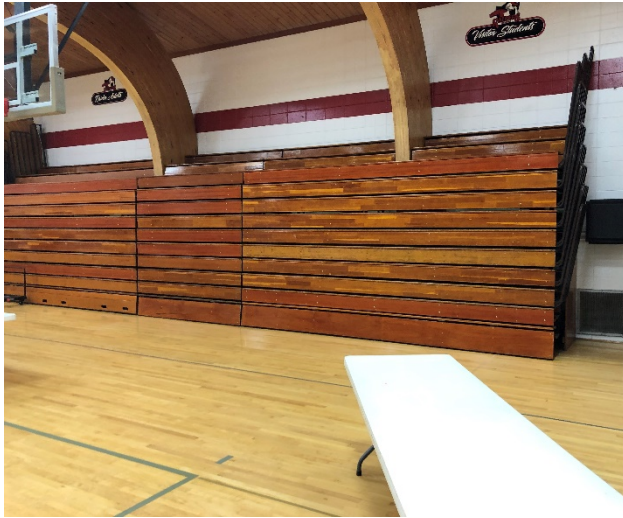
The wood bleachers are in good working condition, however, do not have handrails in the walkways. Add handrails as part of regular maintenance if desired.

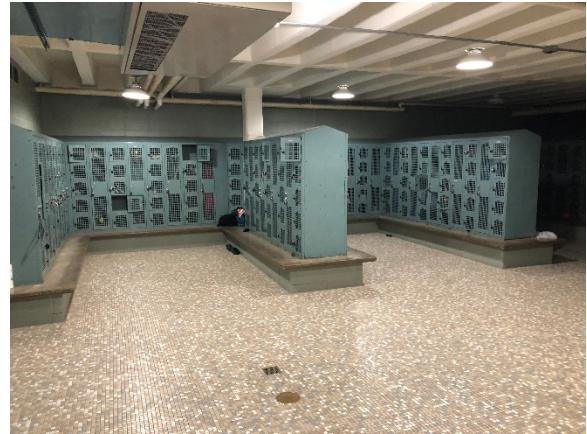
Boys & girls locker rooms lockers are in poor condition and showing signs of major wear.

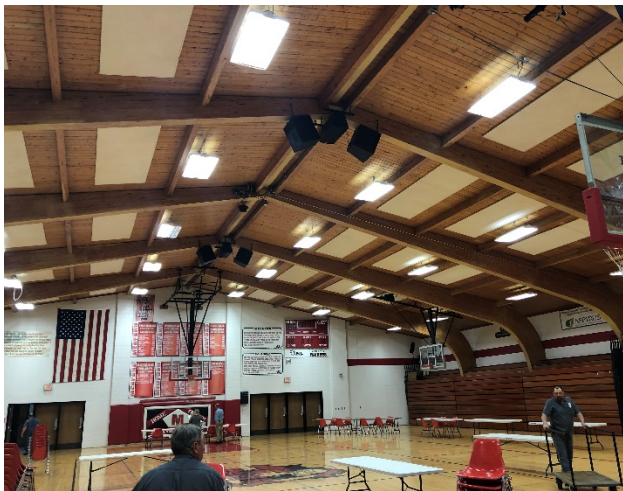
Pictures of the exposed wood deck and beams in the gym.

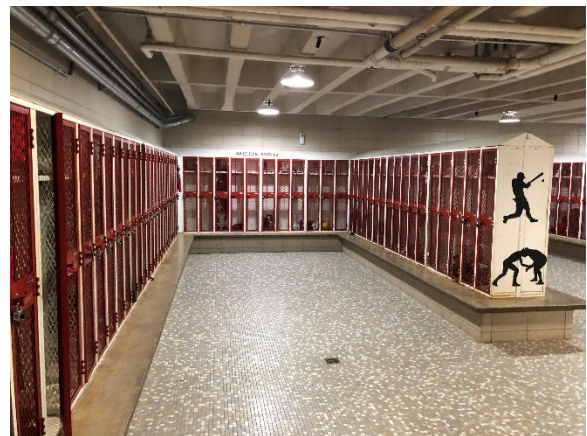
Team locker rooms are in poor condition. Signs of rust and wear are prominent.

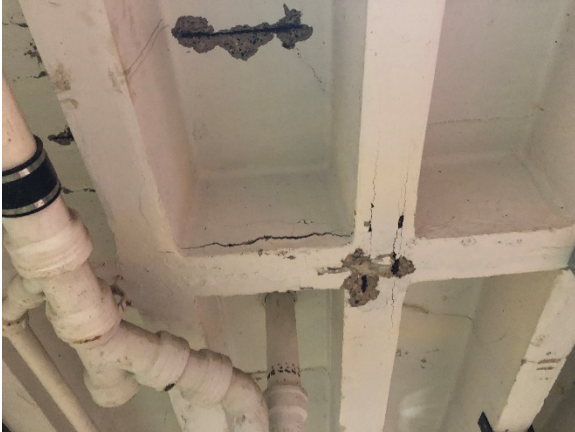
Concrete reinforcing part of the main level floor structure is exposed and in need of repair.

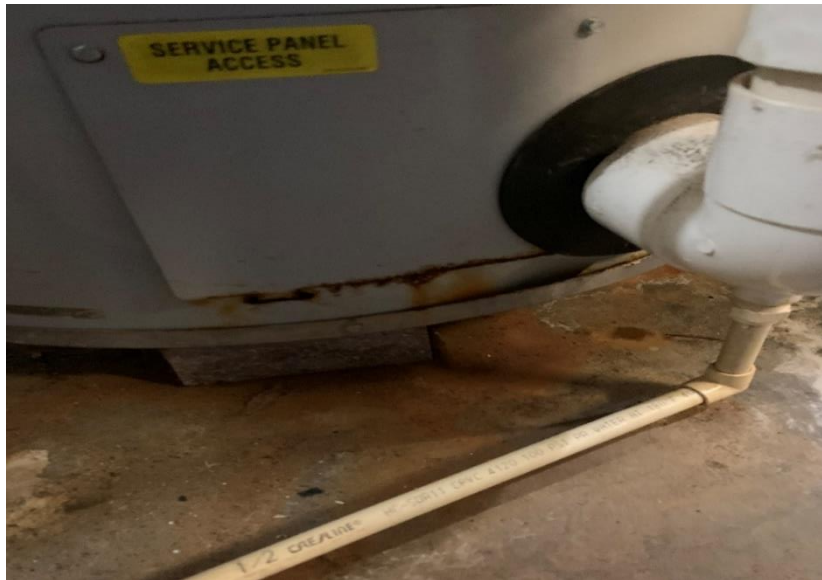
- **Water heater life expectancy:** 10 – 15 years with good maintenance.
- **Remaining life expectancy:** 0 – 2 years for the main building units, 0 years for the technology building unit, 0 years for one of the 20-year-old kitchen water heater, and 1 – 2 years for the 9-year-old kitchen water heater. 2 – 5 years for the indirect water heater.

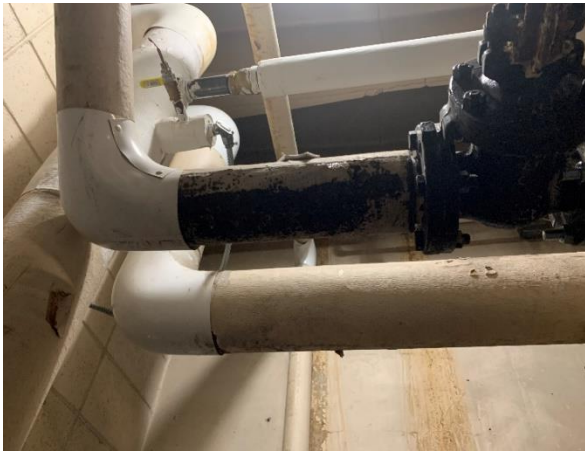
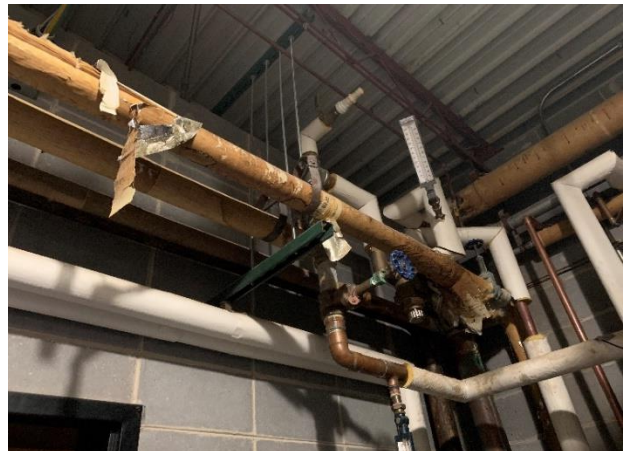
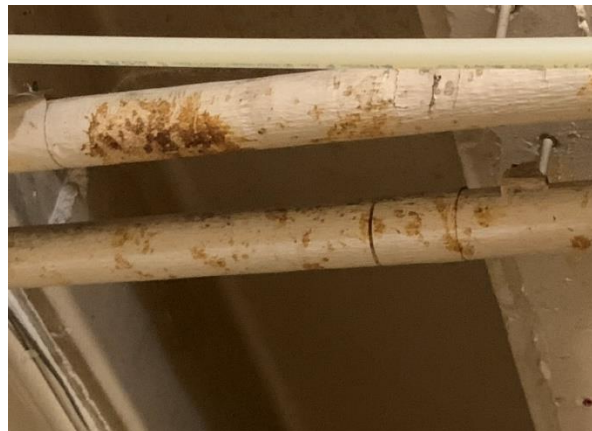
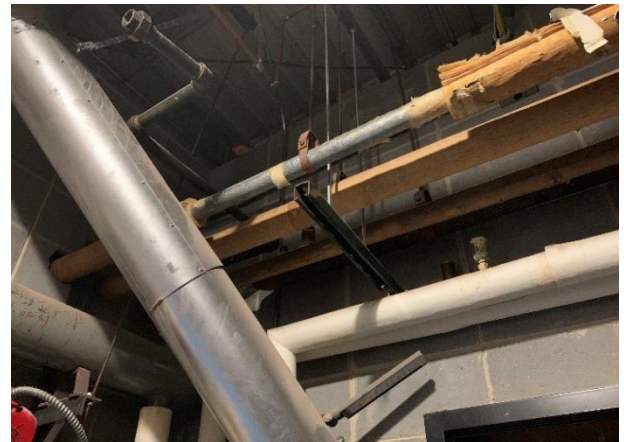
- The original domestic water distribution system was constructed out of galvanized steel piping and galvanized steel fittings. The domestic water system provides hot and cold water to all plumbing fixtures and equipment.
- **Condition of the domestic water distribution system:** the galvanized piping of the domestic water system is in poor condition. The piping displays signs of leakage, corrosion, and failure of valves. The piping is partially insulated in some areas; with most areas having insulation that is severely water damaged, as well as thoroughly covered with mold.
- **Domestic water system life expectancy:** galvanized piping has a life expectancy of +/- 40 years.
- **Remaining life expectancy:** 0 years.

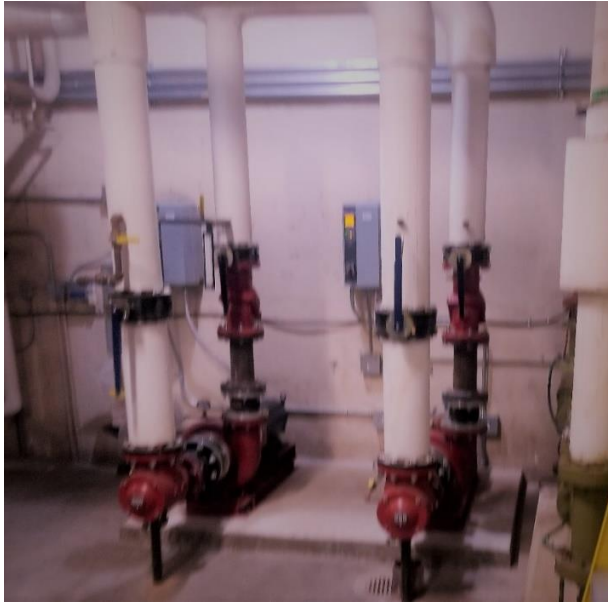
Medford Area Senior High School Facility Assessment

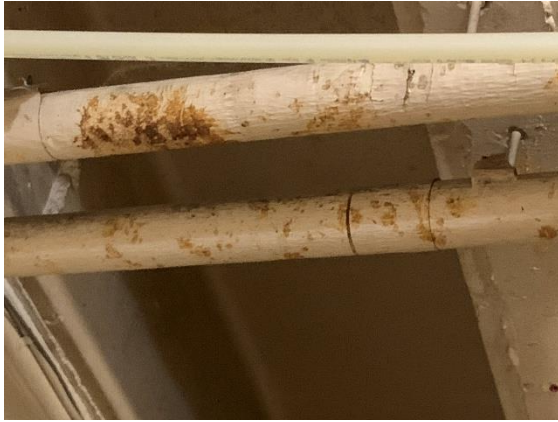
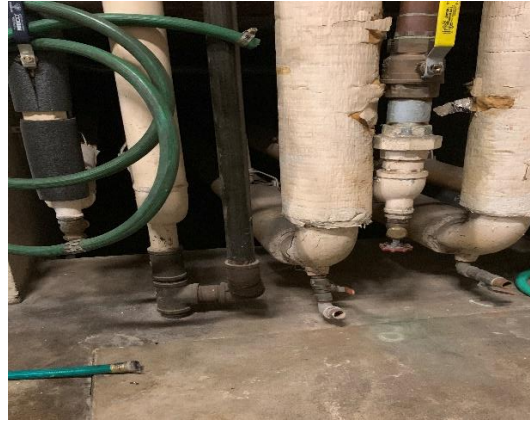
Medford Area Senior High School Facility Assessment

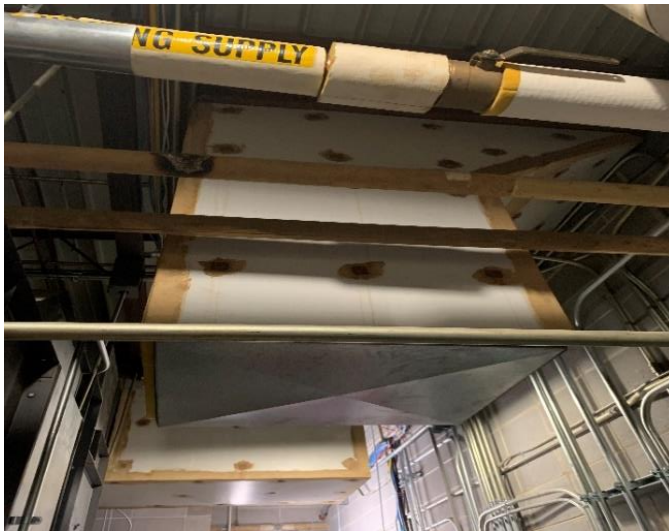
- Ductwork distribution is made of galvanized sheet metal.
- Interior of ductwork was observed to be dirty.
- Duct insulation is missing and/or damaged in several areas.
- Condition of ductwork: ductwork condition ranges from fair to poor, with corrosion showing up in multiple areas.
- Ductwork life expectancy: 20 – 25 years with good maintenance.
- Remaining life expectancy: 0 – 5 years.

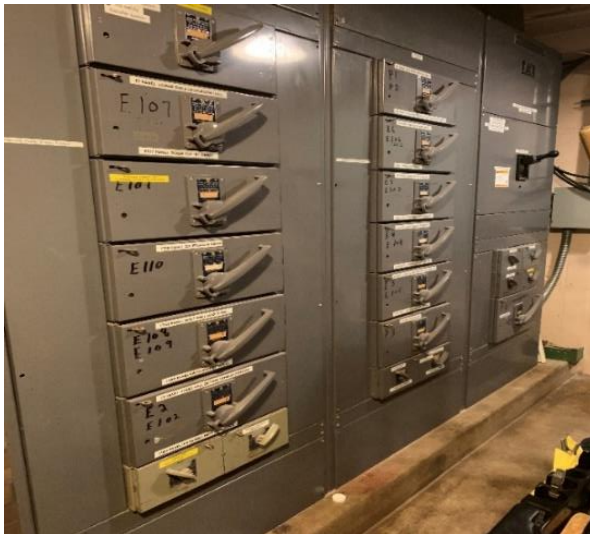
- Main switch board panel is still the original unit and remains in use.
- New panelboards for the pool equipment, mechanical equipment room, and the mechanical/storage space were installed in 2017.
- **Condition of panels and gear:** the newly installed panels from 2017 are in excellent condition, and the existing main panel is in fair condition.
- **Panels and gear life expectancy:** Standards generally recognize that the life expectancy of electric panels is 25 – 30 years.
- **Remaining life expectancy:** 25 years plus for the newer panels, and 0 years for the existing main panel.

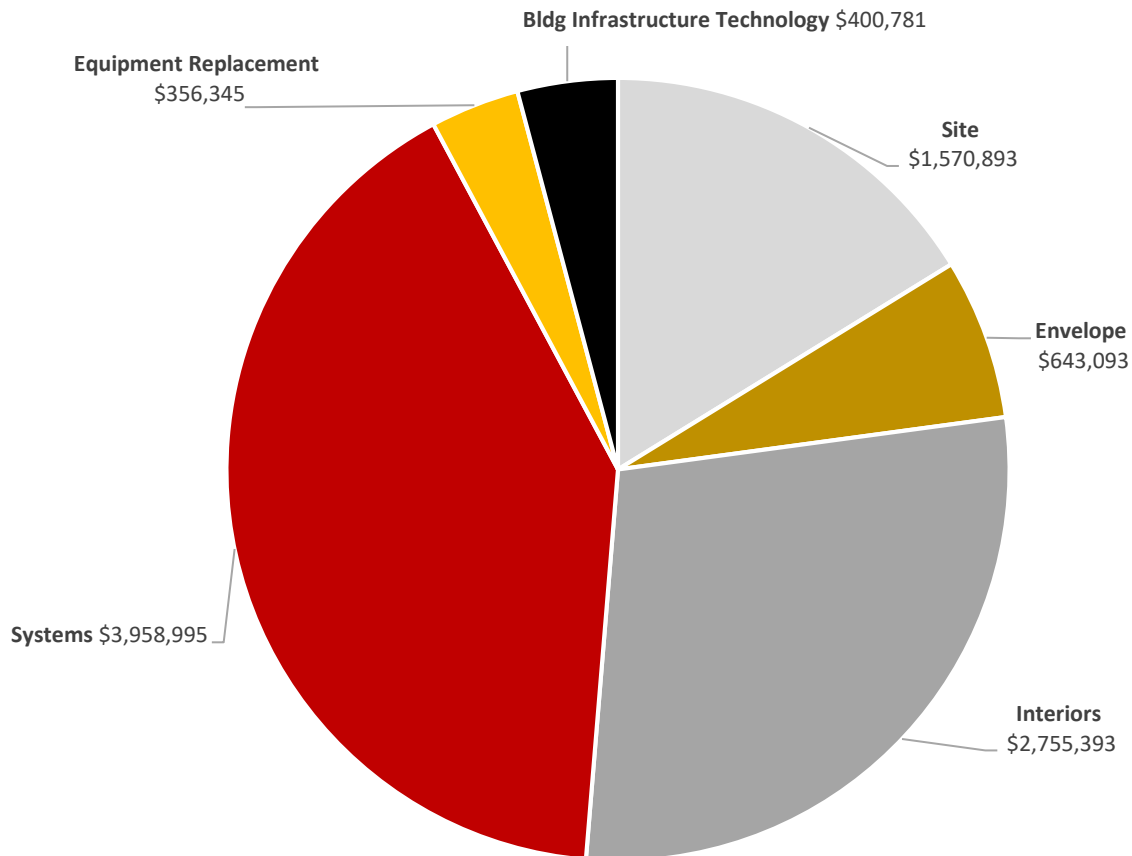
*Costs assume J.H. Findorff & Son Inc. is managing portions of the work.
